Docket No. 217 – Development and Management Plan Inspection

Northeast Utilities Service Company Certificate of Environmental Compatibility and Public Need for the construction of a 345-kV electric transmission line and reconstruction of an existing 115-kV electric transmission line between Connecticut Light and Power Company's Plumtree Substation in Bethel, through the towns of Redding, Weston, and Wilton, and to the Norwalk Substation in Norwalk, Connecticut.

Date: October 18, 2006

Location: 115 kV Underground Route

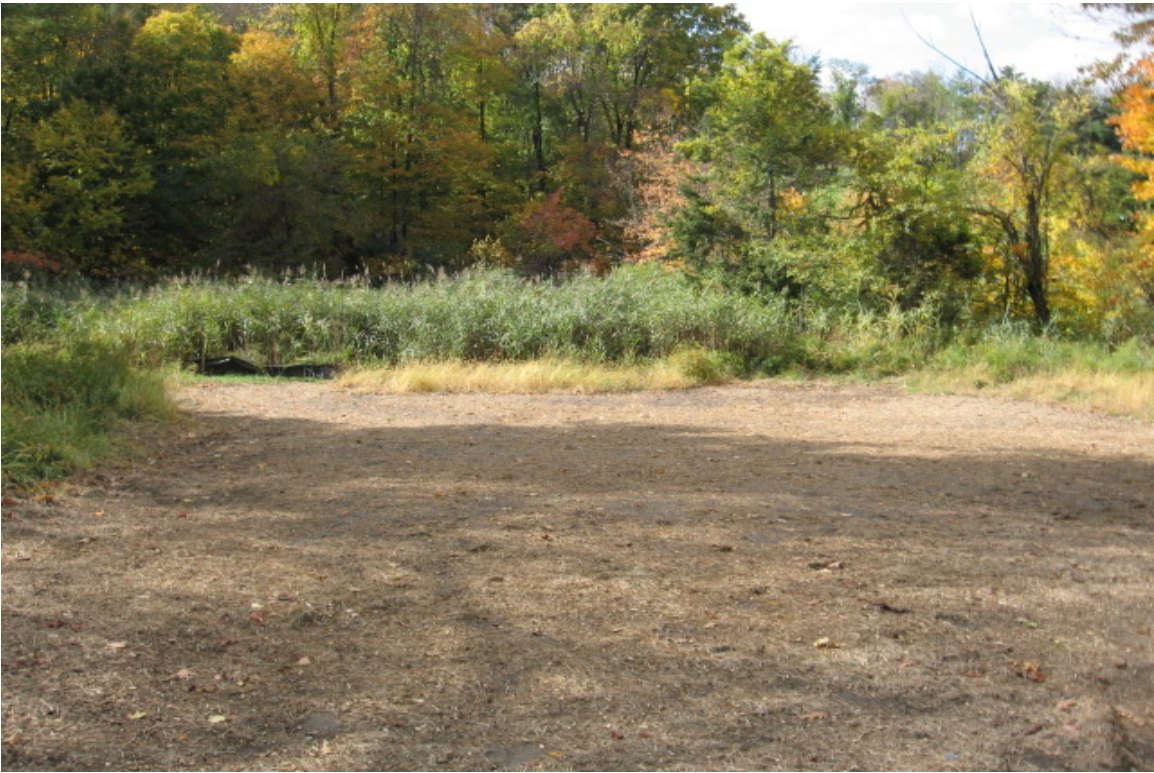
Photo shows the Redding CC storage yard following restoration efforts. Stone was removed and the area was loamed, seeded and mulched. Little grass growth was noted here. 10/18/06

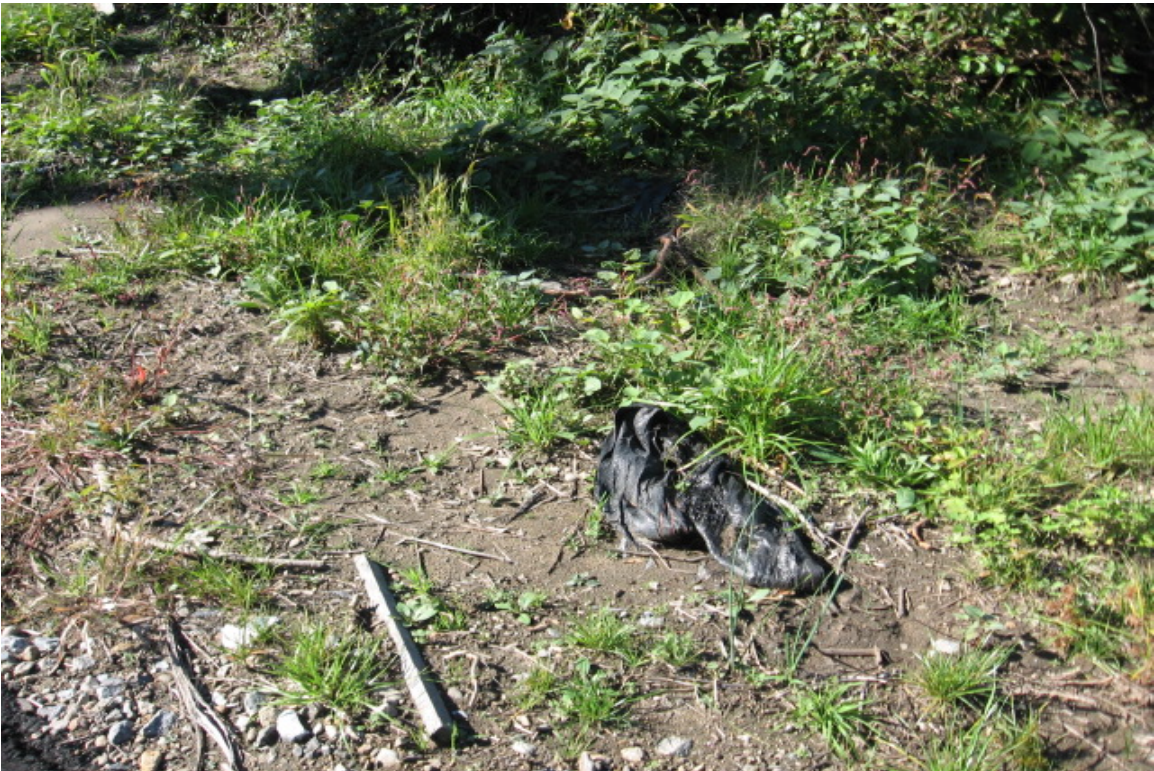
Photo shows an area adjacent to the paved bike path. Remaining silt fence debris should also be removed from under the soil when repairs are made to the asphalt. (This may occur as work under another section of the project.) 10/18/06
